## INSPECTION REPORT

**Project:** Auto Warehouse Tira 187

Inspection:	Site	Source	Off Site
	Storage Area

**Ref Number:** 33.8

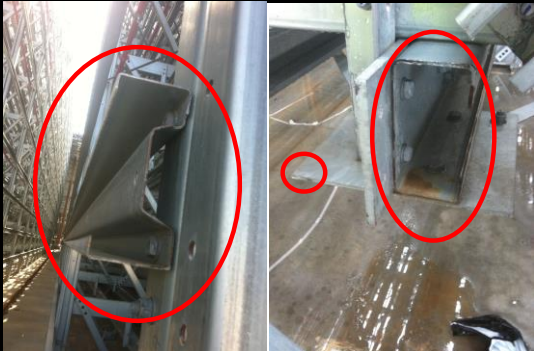
All profiles, purlins edges were not painted by means of approved by submittal 19 00 00-4 Galvanization Repair Paint rust exist. It is independent from thickness of profiles. Signs of Galvanization degradation (white on zinc coating) and rust were observed.	Zinc degradation and steel rust were occur. Products of corrosion may damaged stored things.	All rusted cut edges should be cleaned as per Contract Specification requirements and painted in accordance to submitted 19 00 00-4 Galvanization Repair Paint.	
2	Automated Warehouse In-Rack Shelves System

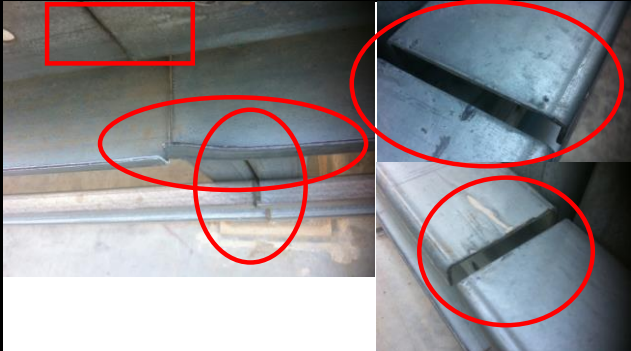
Rust at transversal edges of profiles	Zinc degradation and steel rust were occur. Products of corrosion may damaged stored things.	All rusted cut edges should be cleaned as per Contract Specification requirements and painted in accordance to submitted 19 00 00-4 Galvanization Repair Paint.

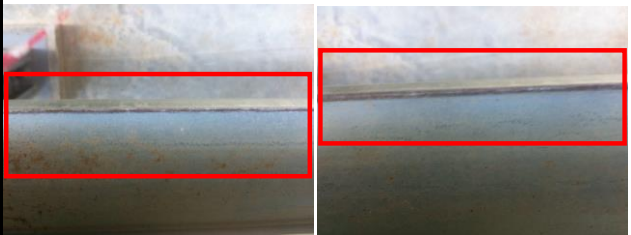
Rust at longitudinal edges of the thin 2-3 mm thickness profiles	Zinc degradation and steel rust were occur. Products of corrosion may damaged stored things.	All rusted cut edges should be cleaned as per Contract Specification requirements and painted in accordance to submitted 19 00 00-4 Galvanization Repair Paint.	
4	Automated Warehouse In-Rack Shelves System

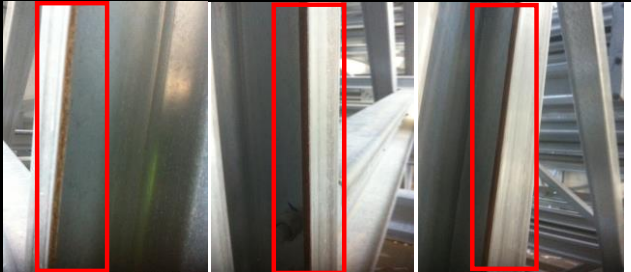
Rust at longitudinal edges of 4 mm thickness profiles	Steel rust was occur. Products of corrosion may damaged stored things.	All rusted cut edges should be cleaned as per Contract Specification requirements and painted in accordance to submitted 19 00 00-4 Galvanization Repair Paint.

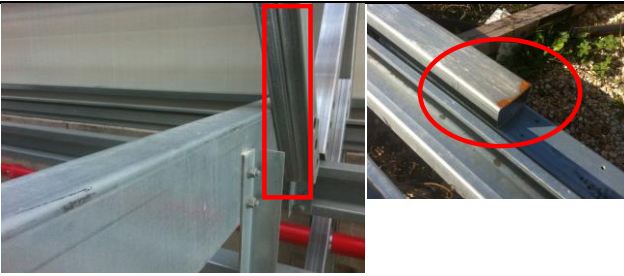
During manufacturing works and assembling profiles were damaged by power and hand tools.	Steel rust was occur. Products of corrosion may damaged stored things.	All rusted cut edges should be cleaned as per Contract Specification requirements and painted in accordance to submitted 19 00 00-4 Galvanization Repair Paint.	
6	Automated Warehouse In-Rack Shelves System

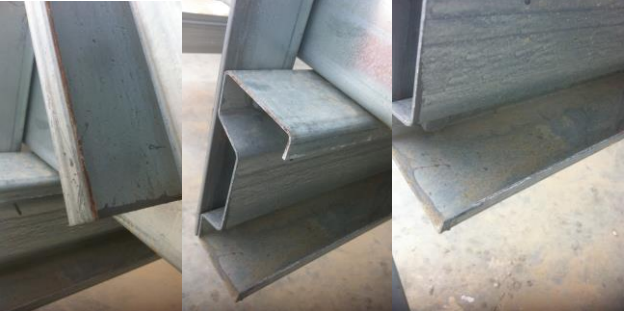
All painted edges have not rust, rust signs, degradation signs up today, independently of direction of cutting.		No activities are needed.	
7	Automated Warehouse In-Rack Shelves System

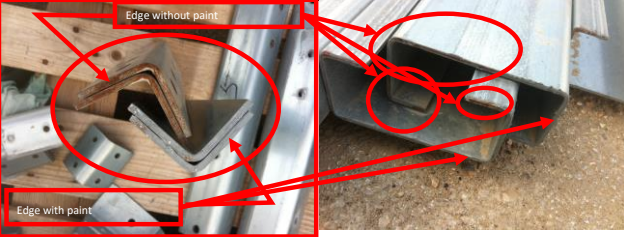
Examples of painted and not painted profiles at the same conditions of TIRA-187 site, exposed to the same ambient conditions more than 7 month.			
8	Automated Warehouse In-Rack Shelves System

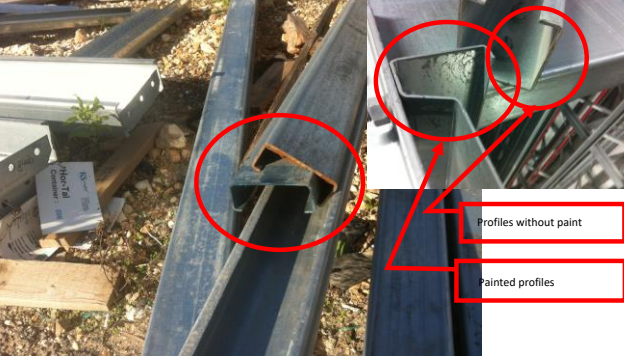
Examples of painted and not painted profiles at the same conditions of TIRA-187 site, exposed to the same ambient conditions more than 7 month.

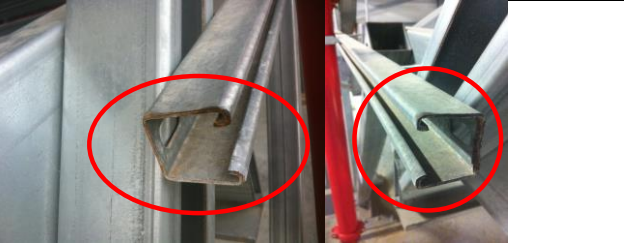
Unistrut profiles cut edges corrosion	Steel rust was occur. Products of corrosion may damaged stored things.	All rusted cut edges should be cleaned as per Contract Specification requirements and painted in accordance to submitted 19 00 00-4 Galvanization Repair Paint.	
10	Automated Warehouse In-Rack Shelves System

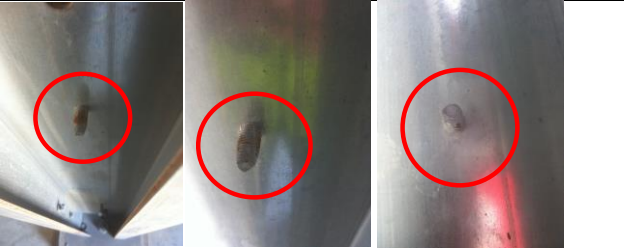
Bolts corrosion	Steel rust was occur. Products of corrosion may damaged stored things.	All rusted cut edges should be cleaned as per Contract Specification requirements and painted in accordance to submitted 19 00 00-4 Galvanization Repair Paint.

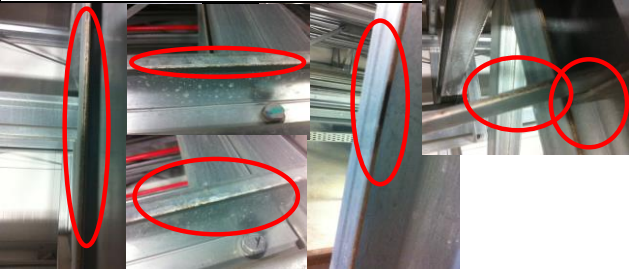
<p>Rust examples on In-Rack Structural Steel Construction.</p>	<p>Steel rust was occur. Products of corrosion may damaged stored things.</p>	<p>All rusted cut edges should be cleaned as per Contract Specification requirements and painted in accordance to submitted 19 00 00-4 Galvanization Repair Paint.</p>
